Plants in the Service of Archaeological Preservation

Naomi F. Miller

Miller, N. F. (2000). Plants in the Service of Archaeological Preservation. *Expedition*, 42 (1), 30-36. Retrieved from http://repository.upenn.edu/penn_museum_papers/33

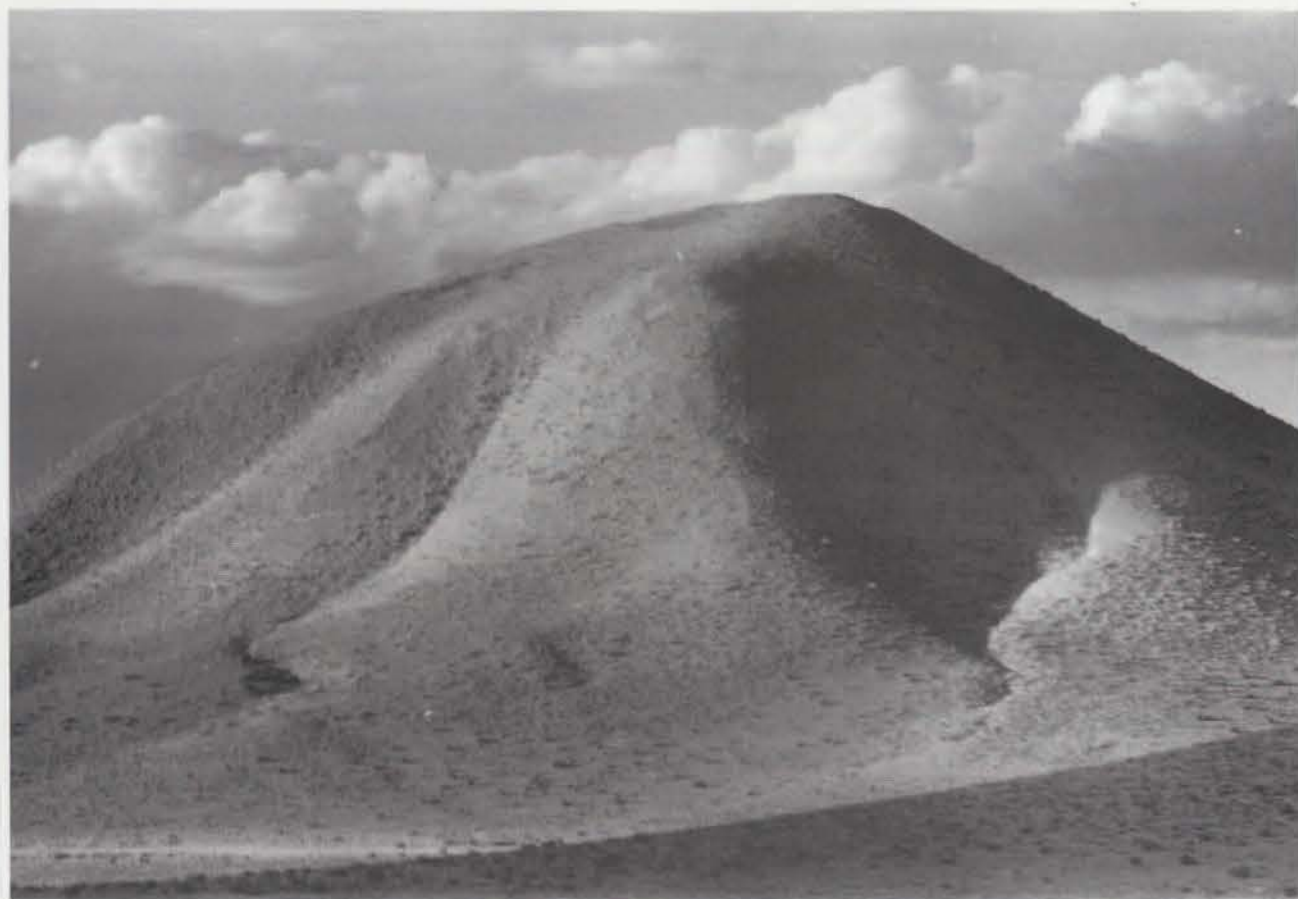
Fig. 1. It is dramatically clear from this photograph, taken in 1957, that the surface of the Midas Mound has been eroding for some time.

Several years ago Dr. İlhan Temizsoy, director of the Museum of Anatolian Civilizations, expressed concern about erosion on the Midas Mound at Gordion (Fig. 1). It occurred to me that the most effective way to reduce soil loss would be to have an uninterrupted cover of plants grow on the mound surface. At that time, the vegetation looked much like the surrounding overgrazed pasture, which is characterized by bare ground, many spiny plants, and plants that defend themselves against grazing goats and sheep

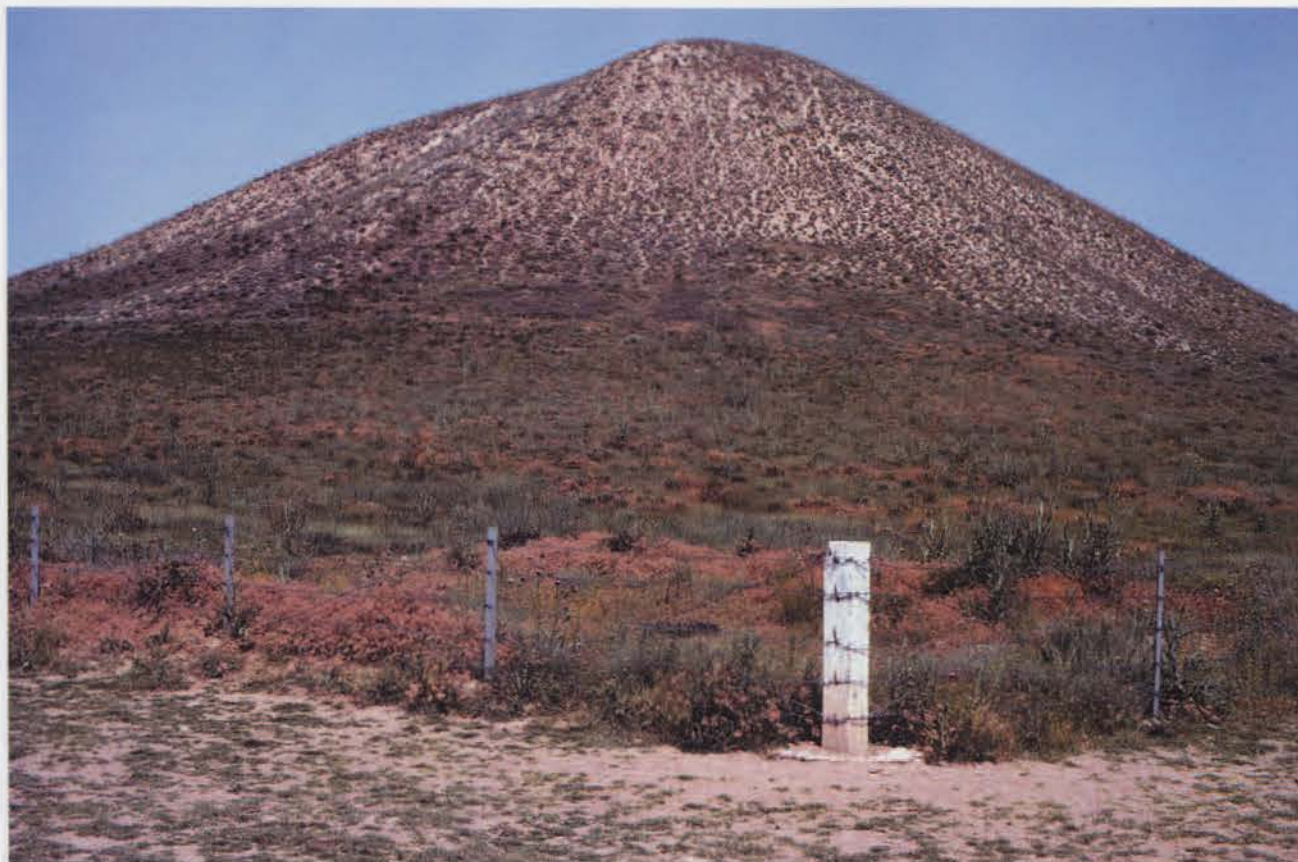
Fig. 4. Protected by the fence, it has not taken long for plants to spread onto the base of the mound. Outside the fence, the flocks still pass by and plant cover is sparse.

Following the concept, "first do no harm," it seemed best initially just to encourage the existing plant cover to spread; thus, in April 1996 the General Directorate of Monuments and Museums erected a fence to keep animals and people off the mound (Fig. 4). By the summer of 1997, a luxuriant cover of grasses and other plants on the lower slopes demonstrated that the fence had begun to work at the base of the mound. Further

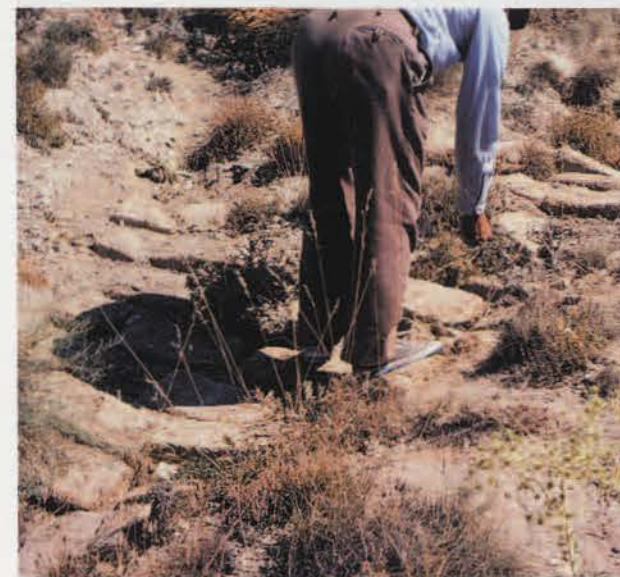
Fig. 5 (top left). Remzi Yilmaz sprinkling seeds between the bricks in one of the erosion channels. The bricks are laid across the channel in rows about 5 cm apart. Although several types of seeds were planted, only annual grasses survived.

The Gordion Project arranged to have 1000 mudbricks from a dismantled village structure placed in two of the erosion channels. The Gordion site caretaker, Remzi Yilmaz, was drafted to supervise the laying of bricks in the fall of 1997 (Figs. 5, 6). The work had to be done by hand because heavy equipment would destroy the soft surface of the mound. As I described the plan to Remzi, the watchman for the dig house listened in. I explained that it was just an "experiment"; if it did not work out, I didn't want Remzi to blame himself. But then I caught the eye of the watchman. "You think I'm crazy, don't you?" I asked him; he smiled and said, "Well, if it works, you're not crazy."

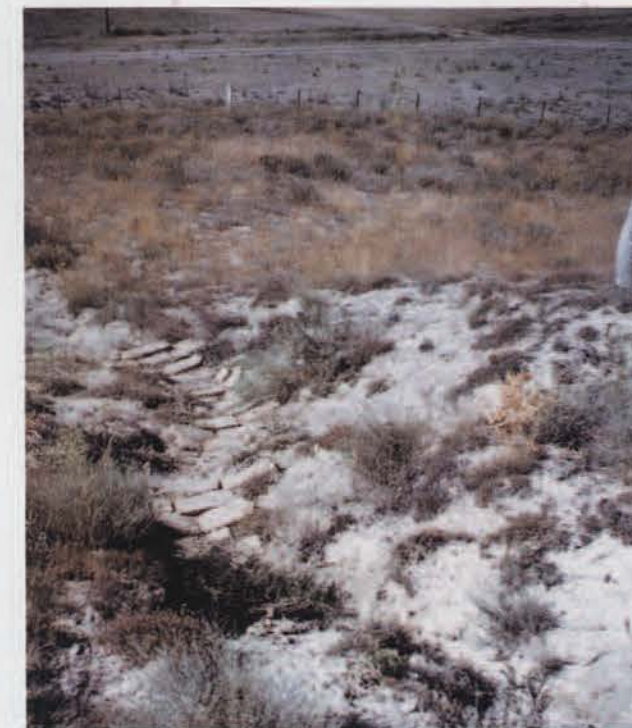
Fig. 6 (top right). Looking downhill after some of the mudbrick was laid in 1997.

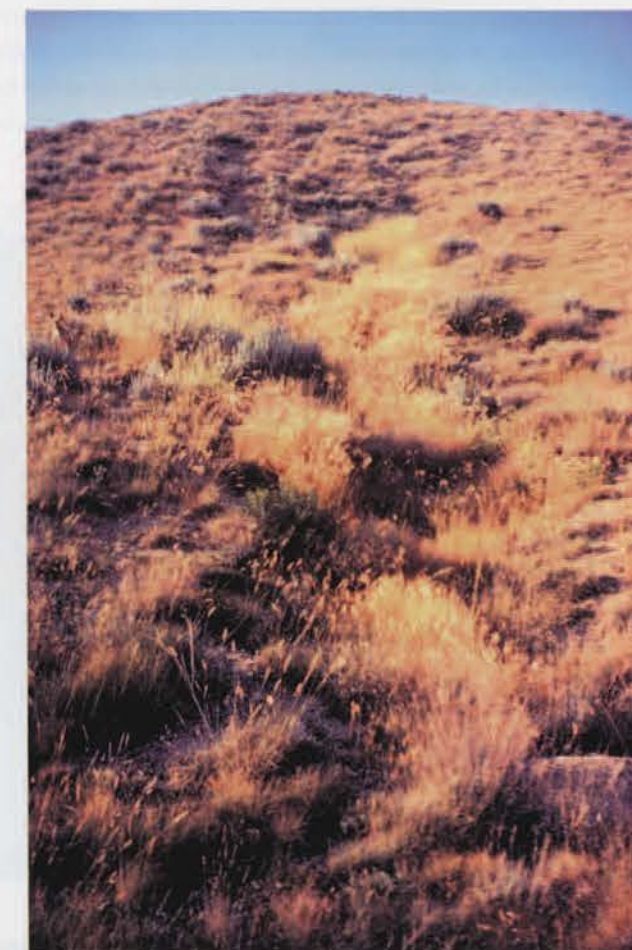
Fig. 7 (right). After two growing seasons, the annual grasses continue to thrive in the bed of the erosion channel. Even better, some of the perennial grasses and other plants that grow on the mound have been able to take advantage of the stabilized soil surface and have spread to the channel.

By the spring of 1998, plants were thriving in both channels where the bricks had been laid (Fig. 7), and I have counted and mapped over 125 different types of plants, distributed according to their own growth requirements (Fig. 8).

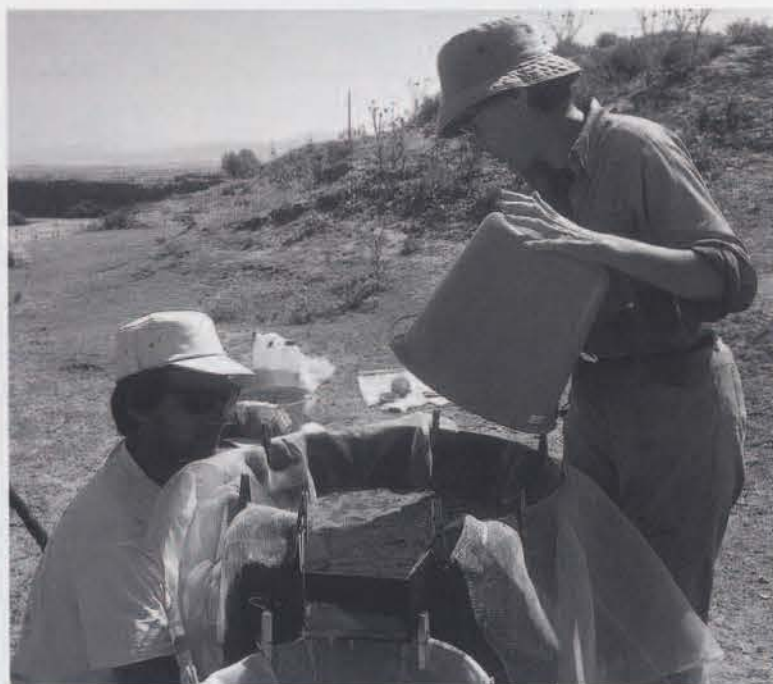
At Gordion, we used a pump-driven flotation device to extract and concentrate the tiny bits of charred seeds and wood from samples of the archaeological deposits. Here I am pouring a bucket of dirt into the tank while my assistant adjusts the water level. As the water flows up and out of the tank, charred seeds and wood bits are caught in a cloth. After they dry, they are examined at low-magnification under a light microscope. Changes through time in the proportions of different types help us interpret corresponding changes in ancient vegetation and land use.

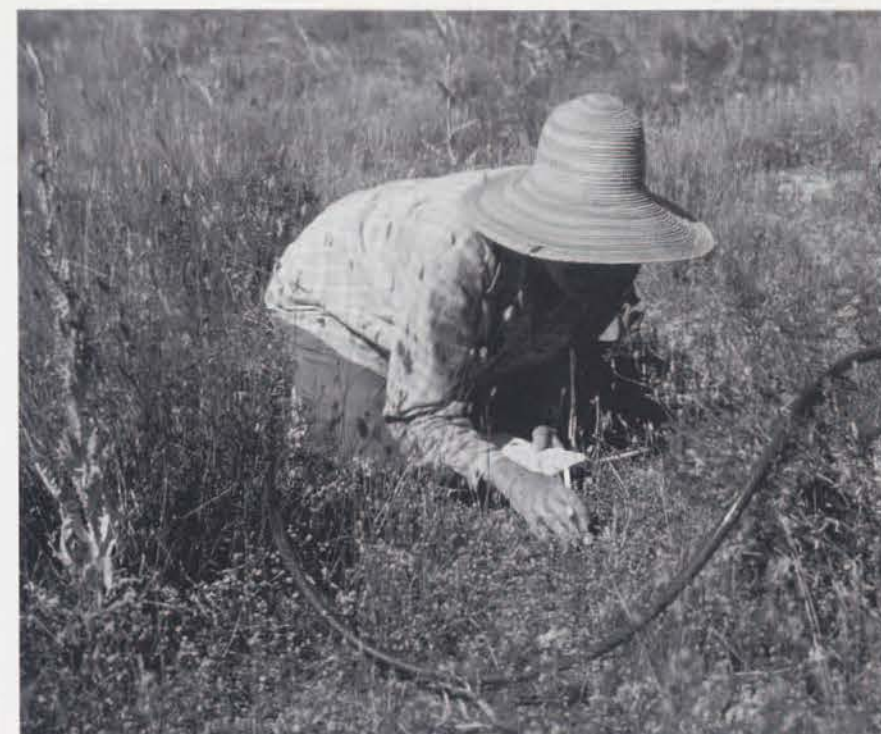
Fig. 8. Part of our conservation efforts involves gathering information as the project evolves. Here, I am in the midst of censusing plants on the Midas Tumulus: every 10 meters along a transect, I identify all the plant types growing in one square meter (the area encircled by the 3.54 m length of garden hose).

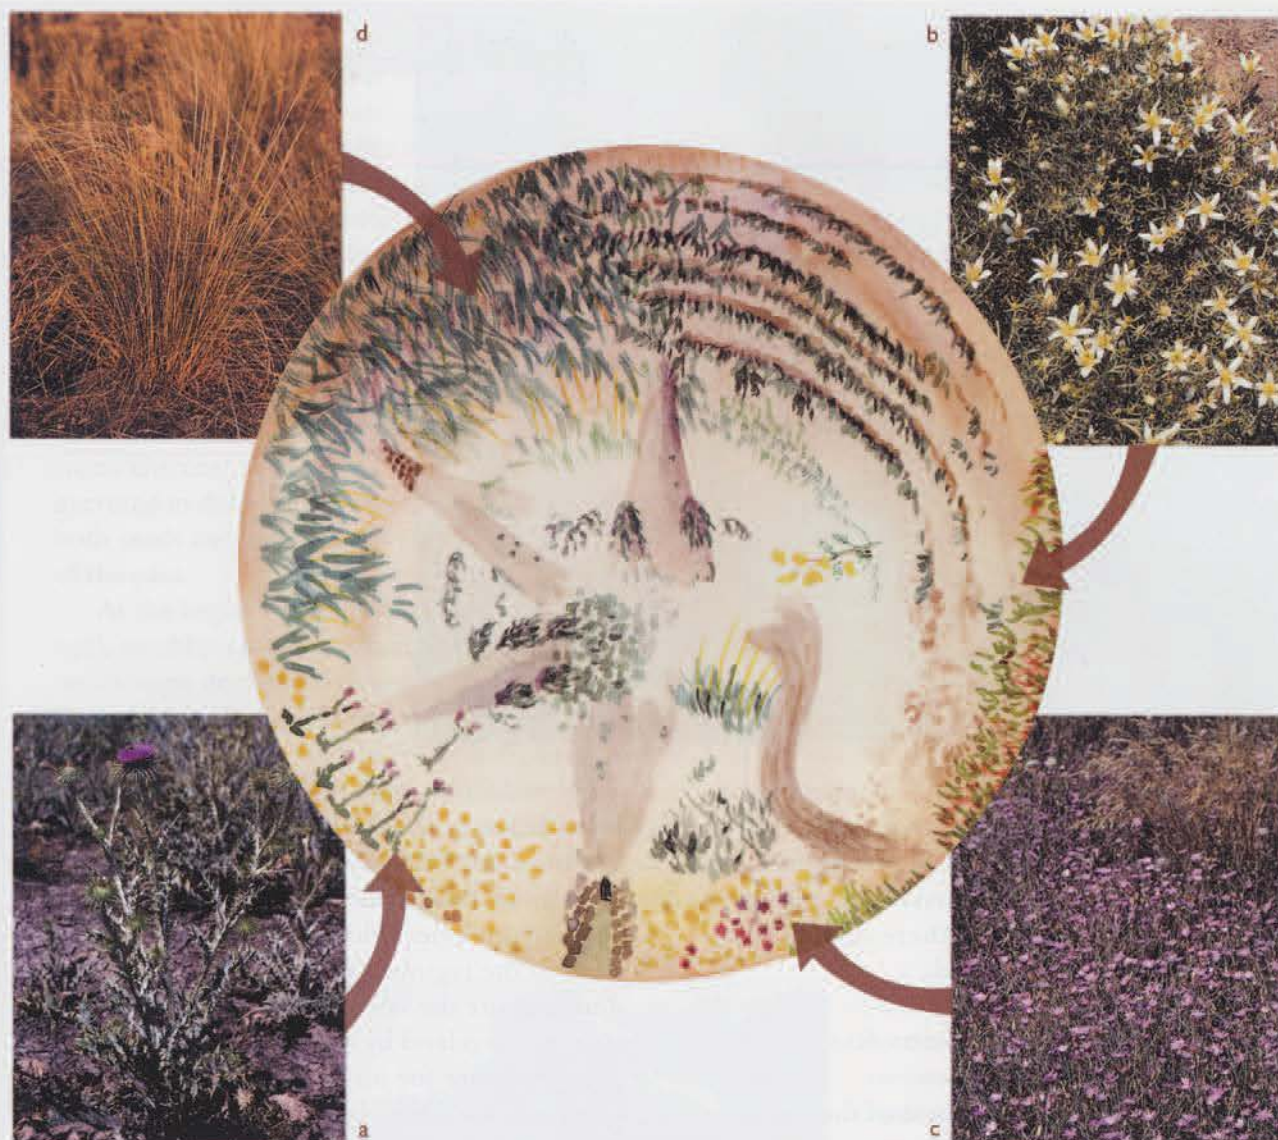
Fig. 9. Schematic watercolor of prominent vegetation on the mound as if seen from the air as we began the experiment with the bricks. Note that plant distribution varies according to slope and aspect. Thistles (probably *Onopordum* sp.; see 'a') thrive on the lower southwest slope and wild rue (*Peganum harmala*; 'b') continues to grow profusely on the southeast side of the mound along one of the main paths to the village from the surrounding pastureland. A small member of the daisy family (*Xeranthemum inapertum*; 'c') grows toward the base on the south side. Wormwood (*Artemisia* sp.), so common but nondescript that I did not think to paint it, is relatively sparse only in the northeast sector. The painting also illustrates trails beaten through the wild thyme by sheep in years past on the northeast side, and perennial grasses thriving on the north side. One of these grasses, *Stipa holosericea* ('d'), is an important part of the native steppe vegetation of central Anatolia and makes a fine fodder.

The mapping demonstrates that there is no one plant or even group of plants that is best for the mound (Fig. 9). For example, one perennial grass, *Stipa arabica*, does very well in the southeast sector, while another one, *Bromus cappadocius*, is most abundant in the north sector.
